AAI Case Reference: 13/2011

PRELIMINARY UPDATE

SERIOUS INCIDENT FACTUAL REPORT

RUNWAY EXCURSION

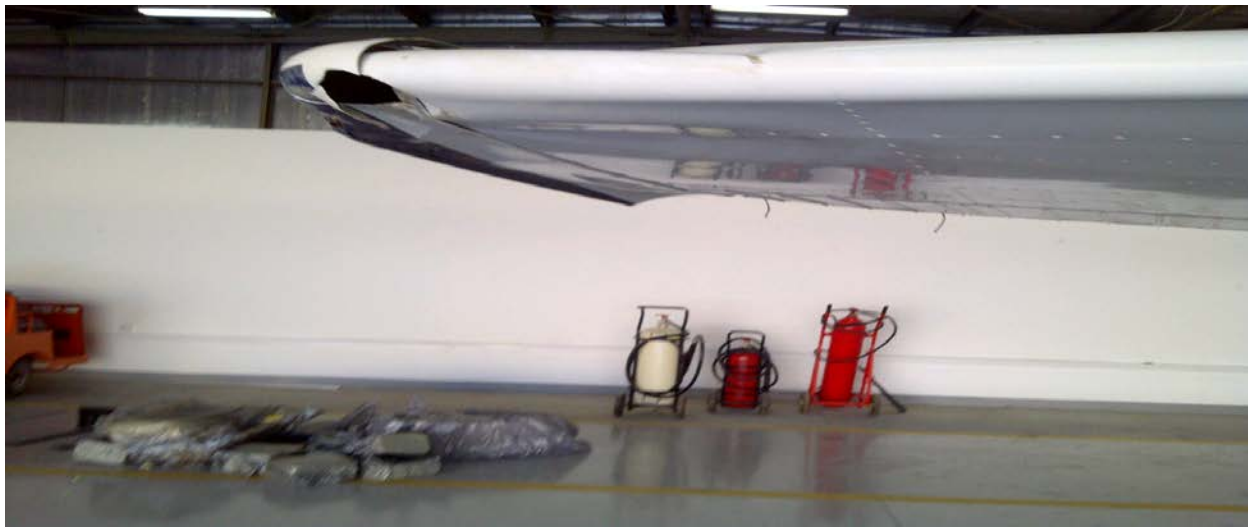
1. Engine Propeller
2. Right Hand Wingtip
3. Right hand wing outermost rib together with leading edge skin attaching to the rib.
4. Right hand strobe light lens
5. Right hand NAV lamp lens.
6. As a result of the propeller damage, and as per the Aircraft Engineer, the Engine will require inspection.

Figure A1-1 : Damaged Right Hand Outboard Wing

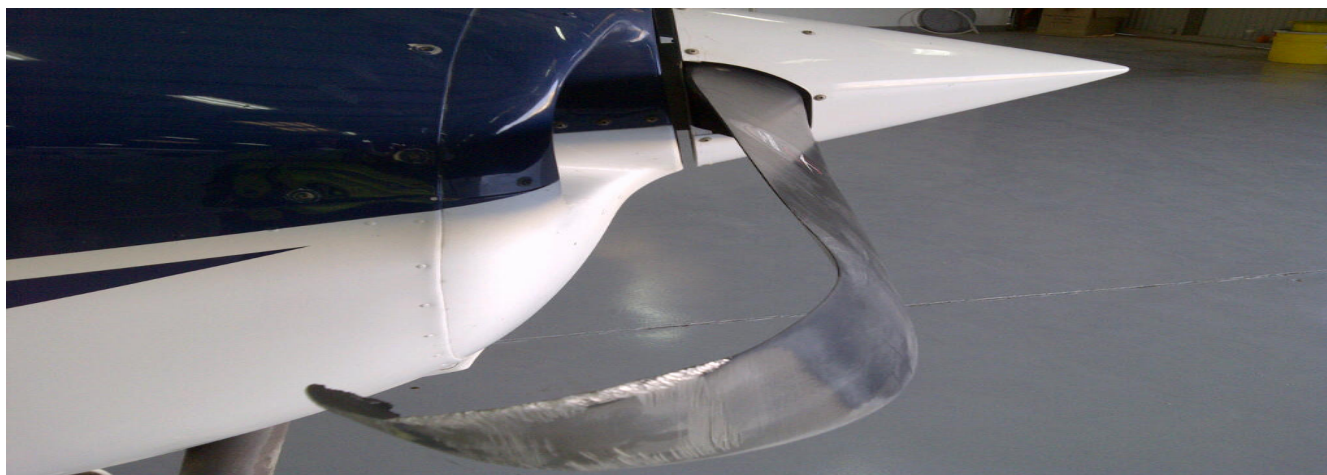
Figure A1-2: Damaged Engine Propeller

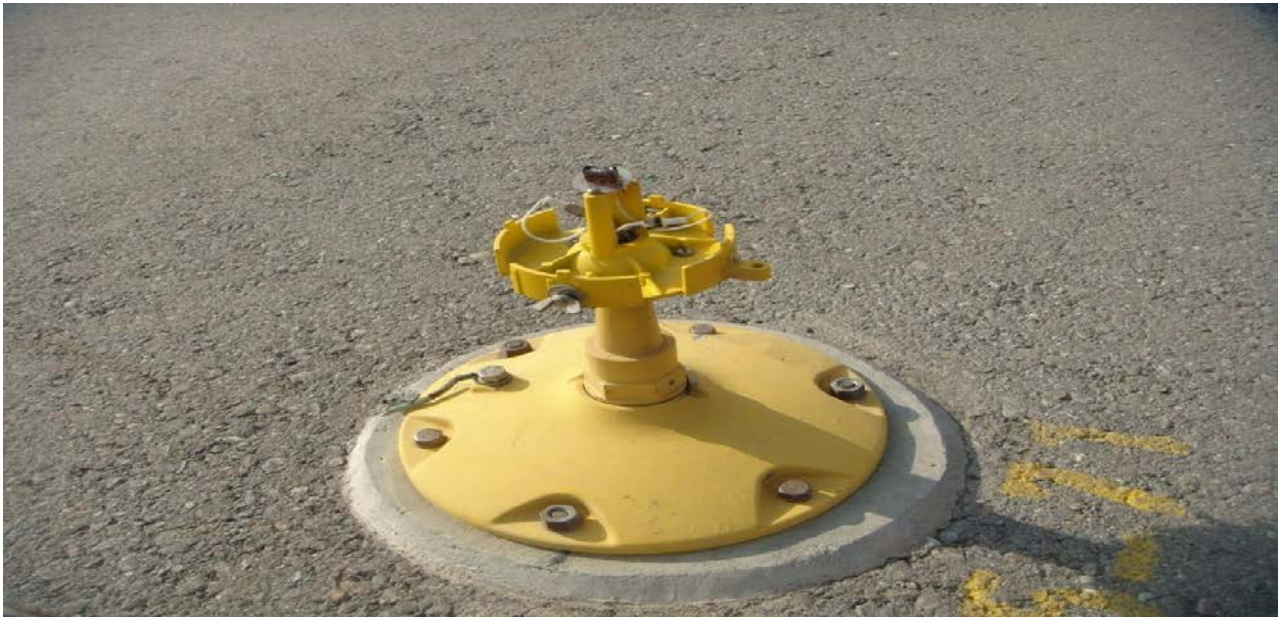
Except for one Airfield Ground Light, AGL, on the edge of the runway there were no other damage such as buildings, vehicles, navigation facilities, aerodrome structures and installations was reported. Additionally the Team was not made aware to any significant damage to environment.

Figure A2-1: Damaged Airfield Ground Lighting Equipment
